Sundance Estates Homeowners' Association Quarterly Fire Berm Inspection Report

Date of Inspection: 10/1/2025_____

Period covered: Q1 / Q2 / **Q3** / Q4

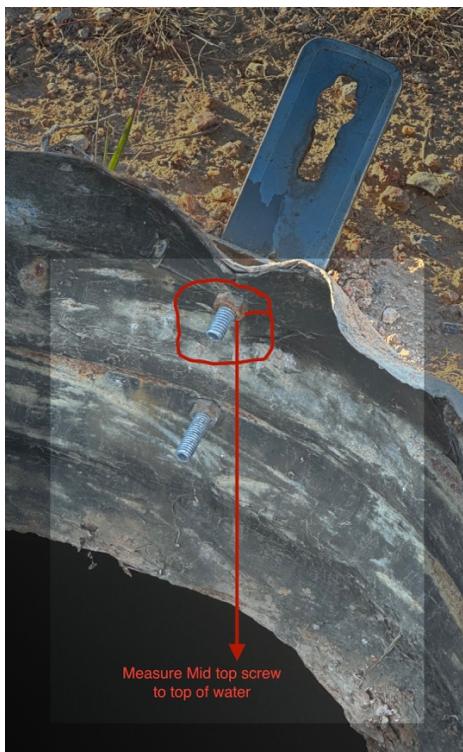
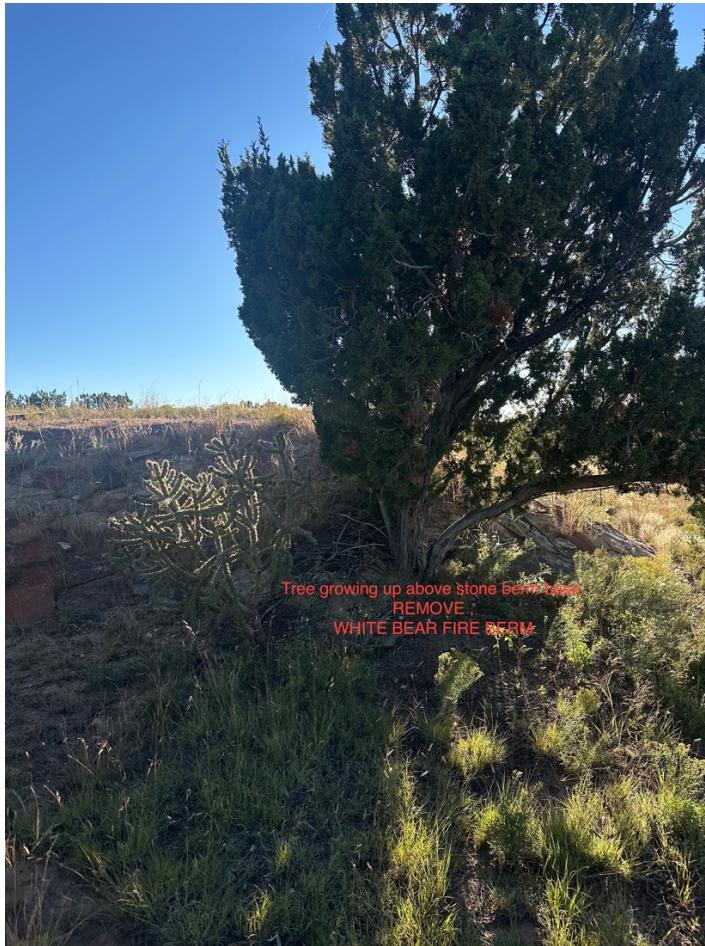
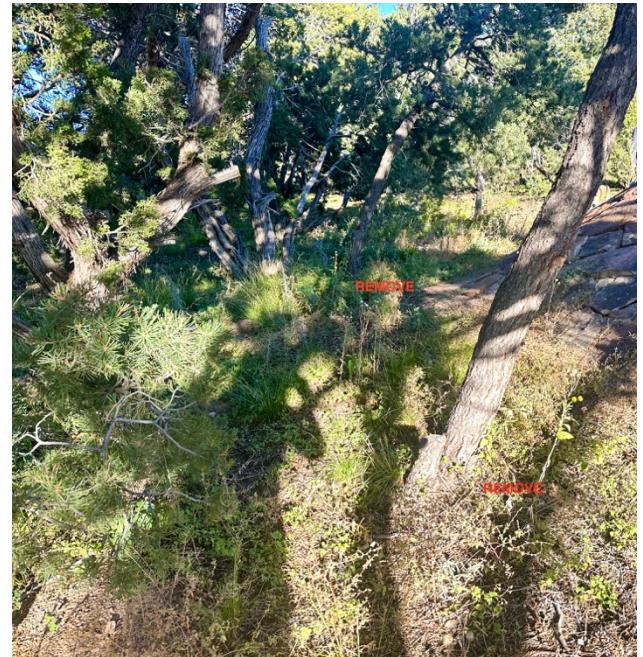
White Bear Court FB

Notes/Observations: This is the first inspection since the tanks were replaced at Eagle Dancer. With the improved float system, we no longer need to open the ports. Sundance Ct FB has 3 – 4 trees located less than 4 feet from base stone. Suggest remove and check for roots. Thank you, Gabe, for again cutting grass around and on top of Sundance Court Fire Berm. White Bear Court has 1 tree about 2 feet up on stone berm and 1-2 trees too close at the base –

remove. Grass and weeds around White Bear need to be trimmed. Should this become part of Ricky's contract?
WE SHOULD FILL WHITE BEAR COURT AND AUDIT FOR LEAKAGE. Some of the measurements are down 4-5 inches and I don't think this is from measurement differences.

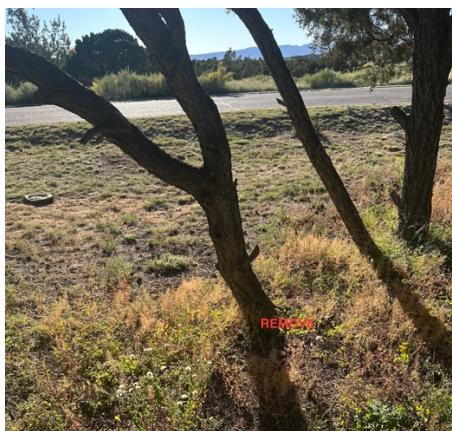
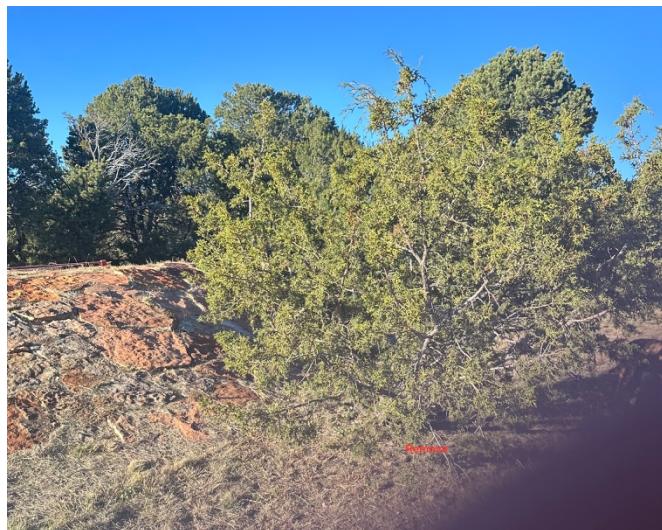
Sundance Court Fire Berm: Trees too close to Berm Base Review and remove trees within 8 feet of berm base.
